ES_LPC1850/30/20/10

Errata sheet LPC1850, LPC1830, LPC1820, LPC1810

Rev. 7.2 — 20 September 2019

Errata sheet

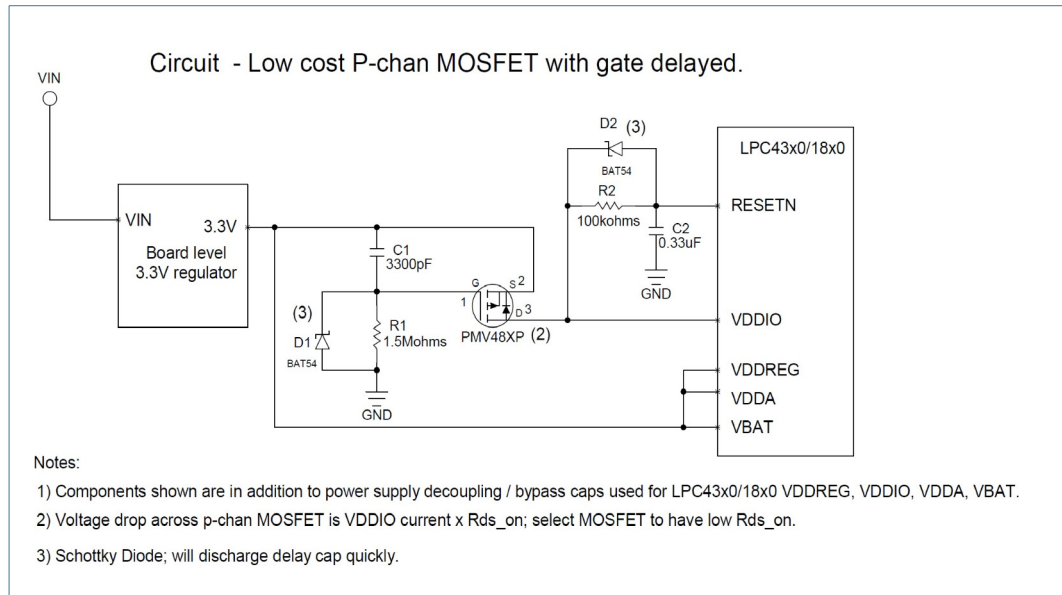
On all packages, repeated power cycling of the device may cause erroneous programming of the OTP banks. During ramp-up, the VDDREG supply voltage does not have enough time to settle and initialize the OTP controller before valid programming voltage is reached on the VPP pin. This may cause accidental programming of the OTP banks. Accidental programming of the OTP banks does not occur during Power-down of the supply voltage.

- Do not tie VDDIO to VDDREG and VDDA pins. The power supplied to the VDDIO pin should be delayed by 2 ms after the power supply on the VDDREG and VDDA pins stabilizes at the operating voltage level. The signal to the RESETN pin must also be delayed by 2 ms after the power supply on the VDDIO pin stabilizes at the operating voltage level.

The following circuit diagram is an example that shows the P-channel MOSFET with the gate delayed and the R-C delay circuit connected to the RESETN pin.
