1 Issue description

Improper ordering of eQADC commands may lead to unexpected result swap in result FIFO. As result FIFO does not contain any flag or other way how to identify which results are read, it is needed to guarantee ordering of results is the same as the ordering of commands.

Document identifier: EB00927

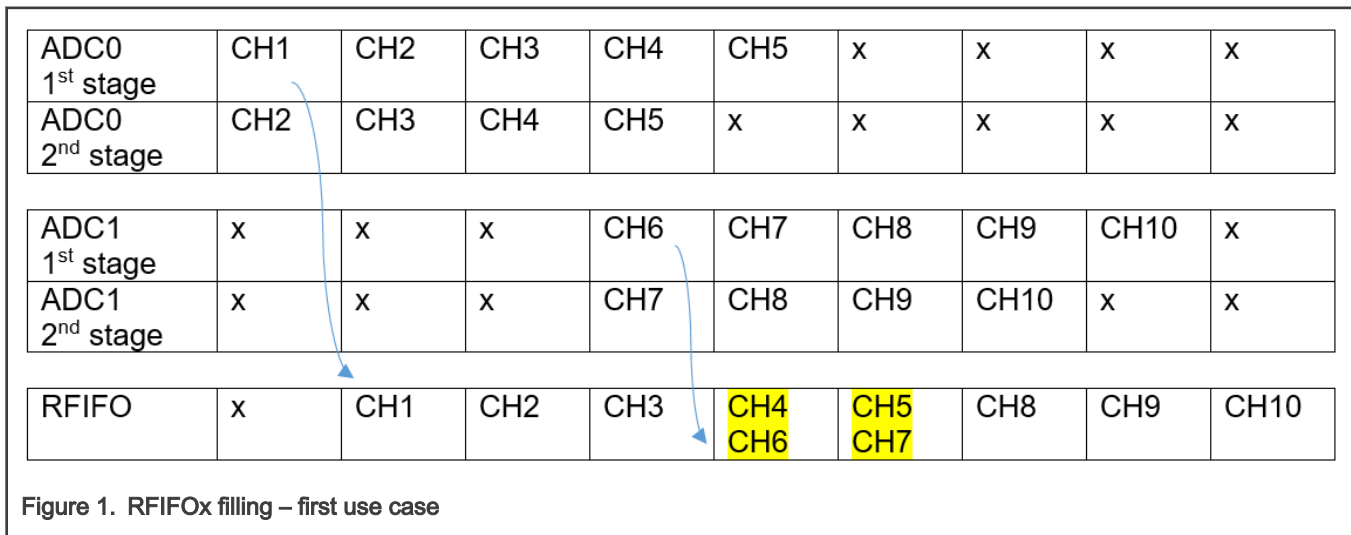
1.1 Swap caused by two-stage command buffers

One reason can be caused by a two-stage command buffer that is used with every ADCs (in the reference manual marked as CBuffer0 and CBuffer1 - refer to “CFIFO Prioritization Logic” figure, find it in every device’s RM equipped with eQADC).

In case when one buffer is full and the second one is empty, buffered conversion may result in a swap of the result.

The diagram below shows filling of eQADC command buffers and converted results stored in result FIFO. Beats given by ADC clock lies on the X-axis. Result swap is highlighted.

- 1) Use two command queues and two results queues (therefore two different return tags).
- 2) Use one command queue and two results queues by using two different return tags.
- 3) If forced to use one results queue, add three dummy conversions with null return tags to keep ADC1 busy until ADC0 returns the last result.
- 4) Keep regular alternating of commands assigned to ADC0 and ADC1 (The ABORT feature must be disabled).

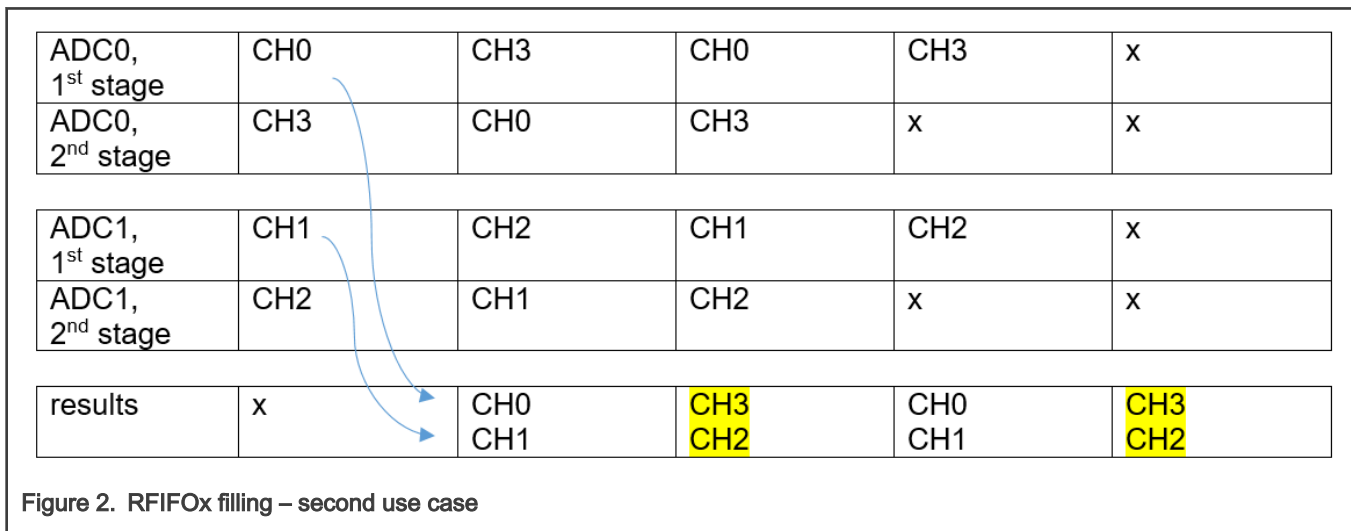
1.2 Swap caused by ADC0 priority in result buffer

“In general received data is moved into RFIFOs as they become available, while an exception happens when multiple results from different sources become available at the same time. In that case, result data from ADC0 is processed first, result data from ADC1 is the only process after all ADC0 data is processed, and finally returned data from the companion module is processed (after all data from ADC0/1 is processed).”

If the sequence is as follows, the resulting swap is present as well.

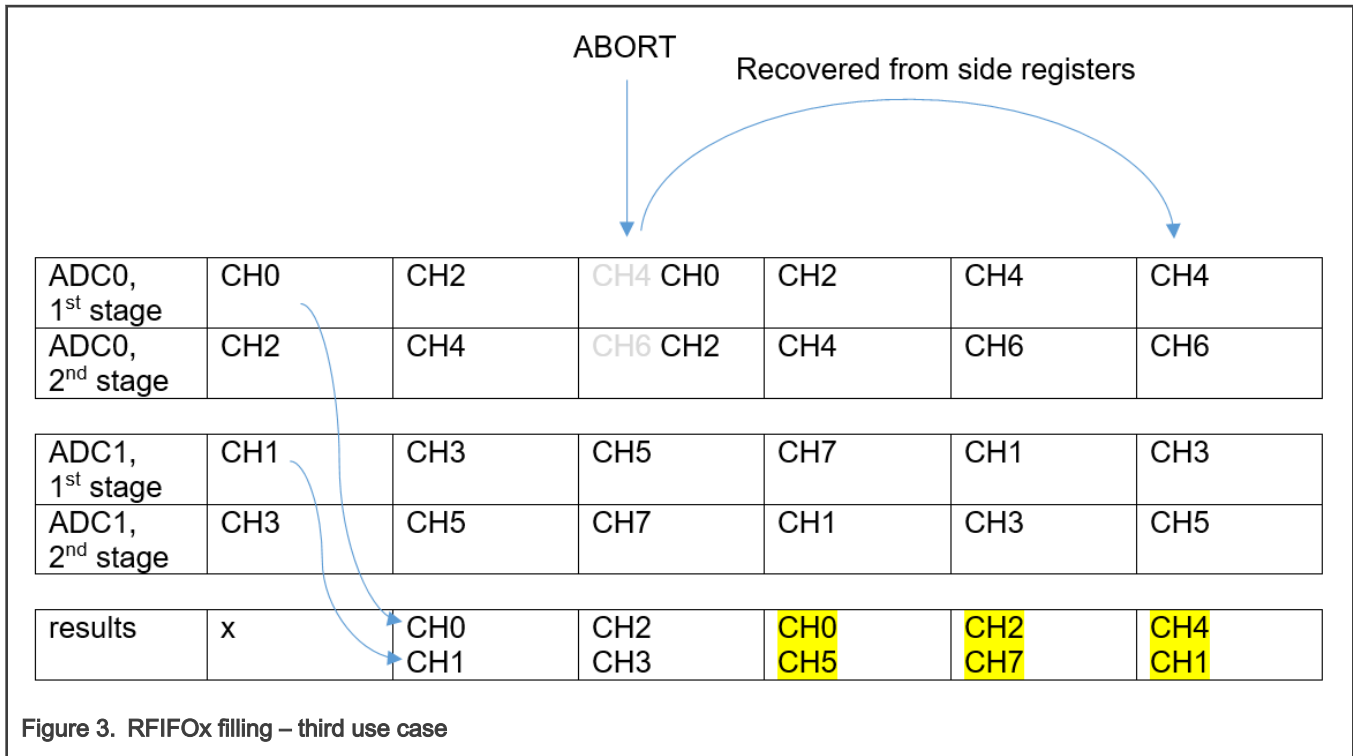
1.3 Swap caused by ABORTing of command in a queue execution

Improper use of the ABORT feature may cause shuffling the results out of the expected order.

In the example configuration below, let us consider ABORT feature is enabled for `CBuffer0` (`EQADC_MCR[ICEA0] = 1`). Triggering of command queue causes abortion of currently executed conversion by ADC0 and these commands are executed after finishing of CFIFO0 execution.

5) Use ABORT functionality with caution.
