Errata to MPC8544E PowerQUICC™ III Integrated Host Processor Family Reference Manual, Rev. 1

This errata describes corrections to the *MPC8544E PowerQUICC™ III Integrated Host Processor Family Reference Manual*, Revision 1. For convenience, the section number and page number of the errata item in the reference manual are provided. Items in bold are new since the last revision of this document.

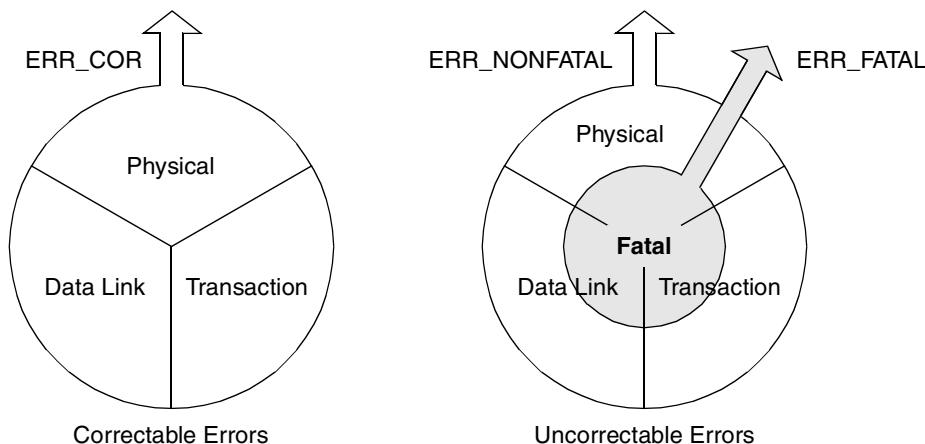
Figure 18-176. PCI Express Error Classification

The PCI Express specification classifies errors as correctable and uncorrectable. Correctable errors result in degraded performance, but uncorrectable errors generally result in functional failures. As shown in Figure 18-176, uncorrectable errors can further be classified as fatal or non-fatal.

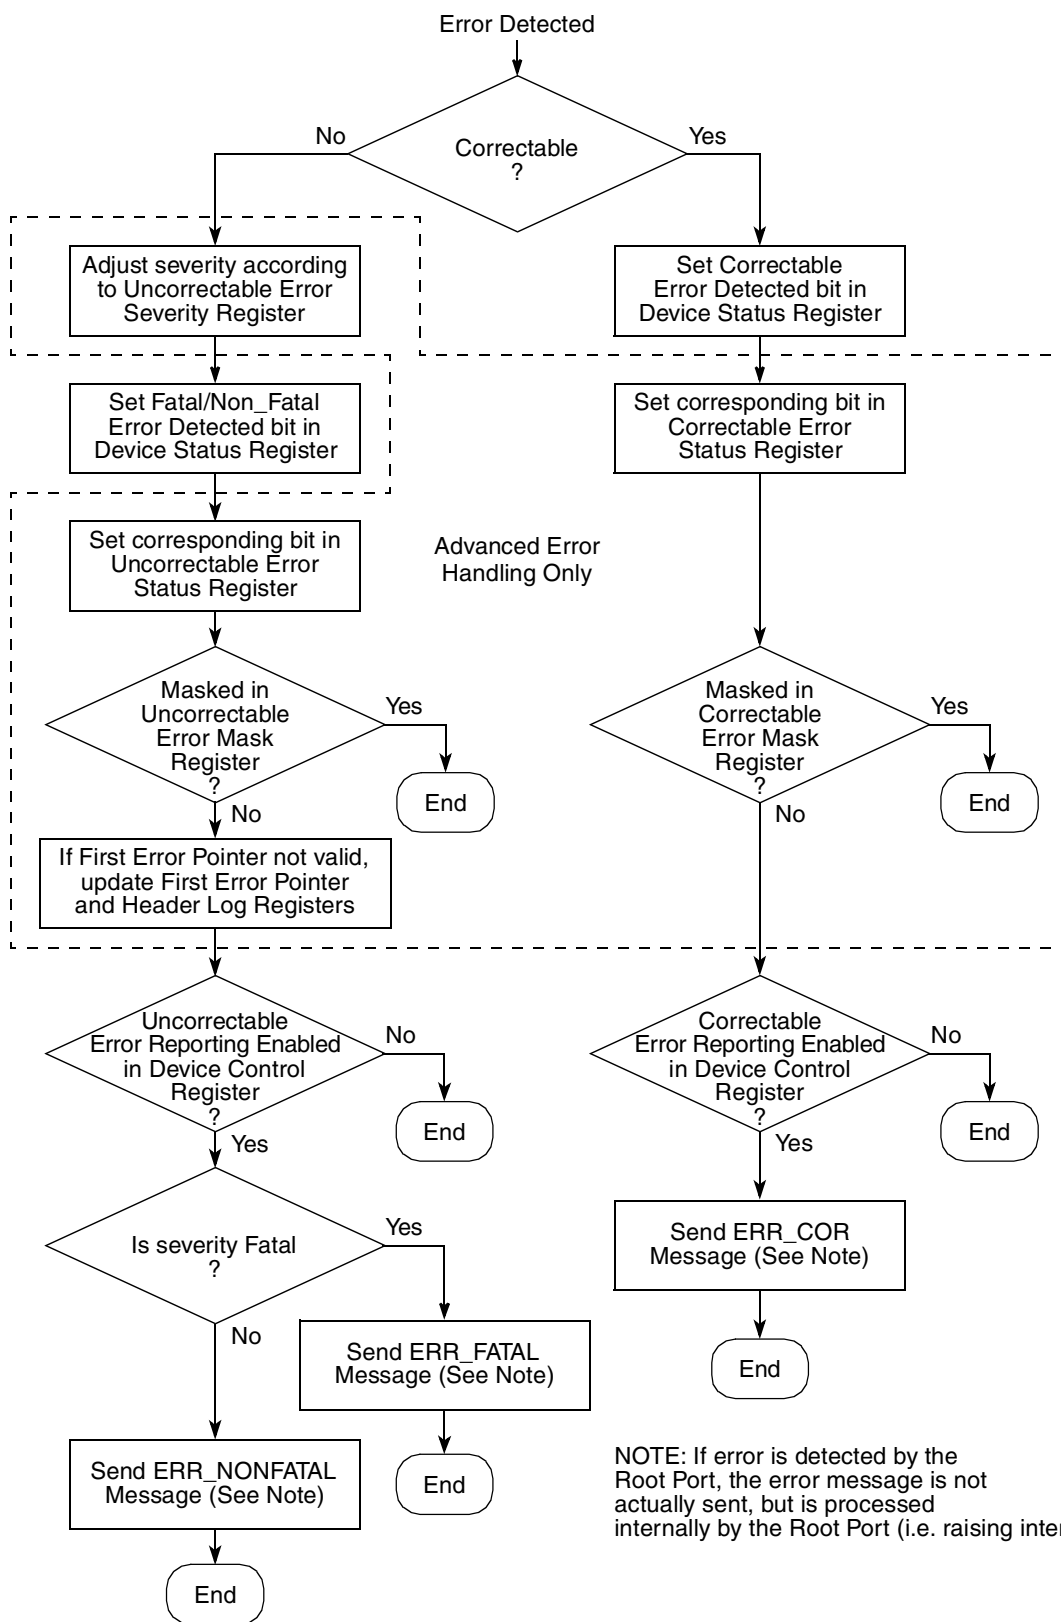
Figure 18-177. PCI Express Device Error Signaling Flowchart

Figure 18-177 shows the PCI Express-defined sequence of operations related to signaling and logging of errors detected by a device. Note that the PCI Express controller on this device supports the advanced error handling capabilities shown within the dotted lines.

NOTE: If error is detected by the Root Port, the error message is not actually sent, but is processed internally by the Root Port (i.e. raising interrupt).

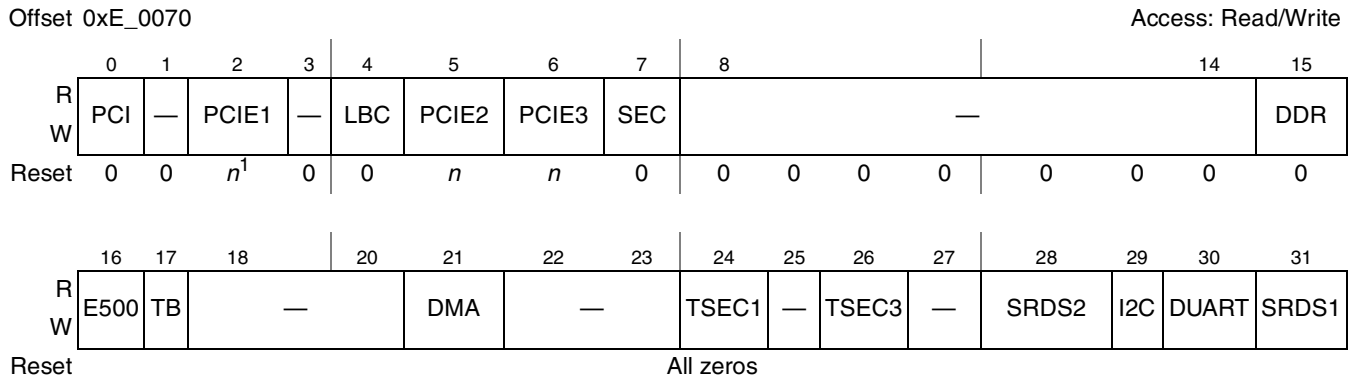
Figure 19-12. Device Disable Register (DEVDISR)

19.4.1.12, 19-14 Added fields SRDS2 and SRDS1 (bits 28 and 31) to Figure 19-12, “Device Disable Register (DEVDISR)” and Table 9-15, “DEVDISR Field Descriptions.” The register figure and field description table changes should appear as follows:

¹ * n bits depend on the state of the corresponding POR configuration signals at reset.
